# Property Solutions

**INDEPENDENT SAFE AND SANITARY REPORT**  
**4 Marco Polo Place, Lynfield, Auckland**  
**Lot 64 DP 127967**

This report details our investigation & recommendations into the unauthorised building alteration work that has taken place at the above property.

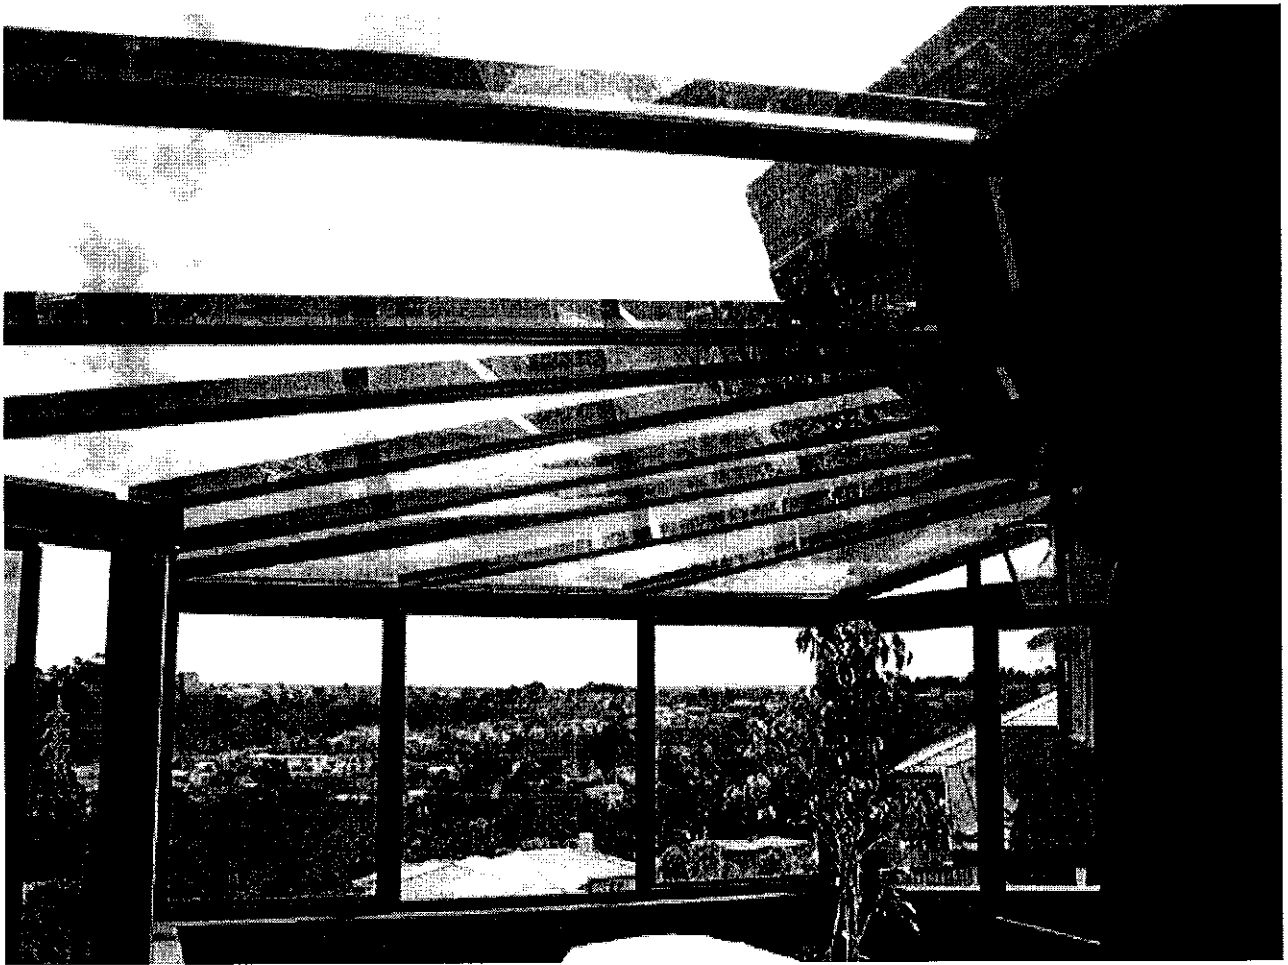
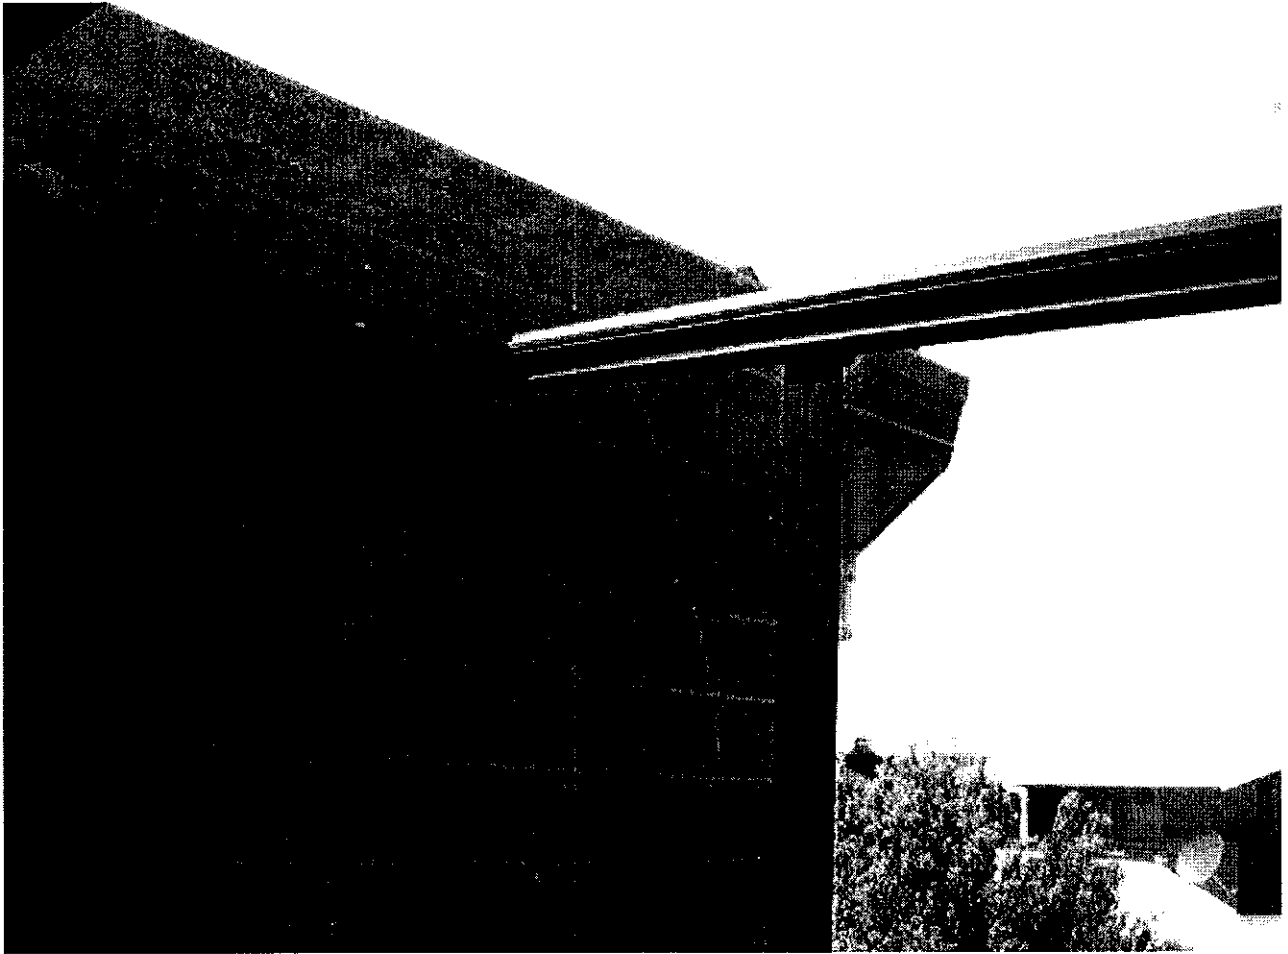
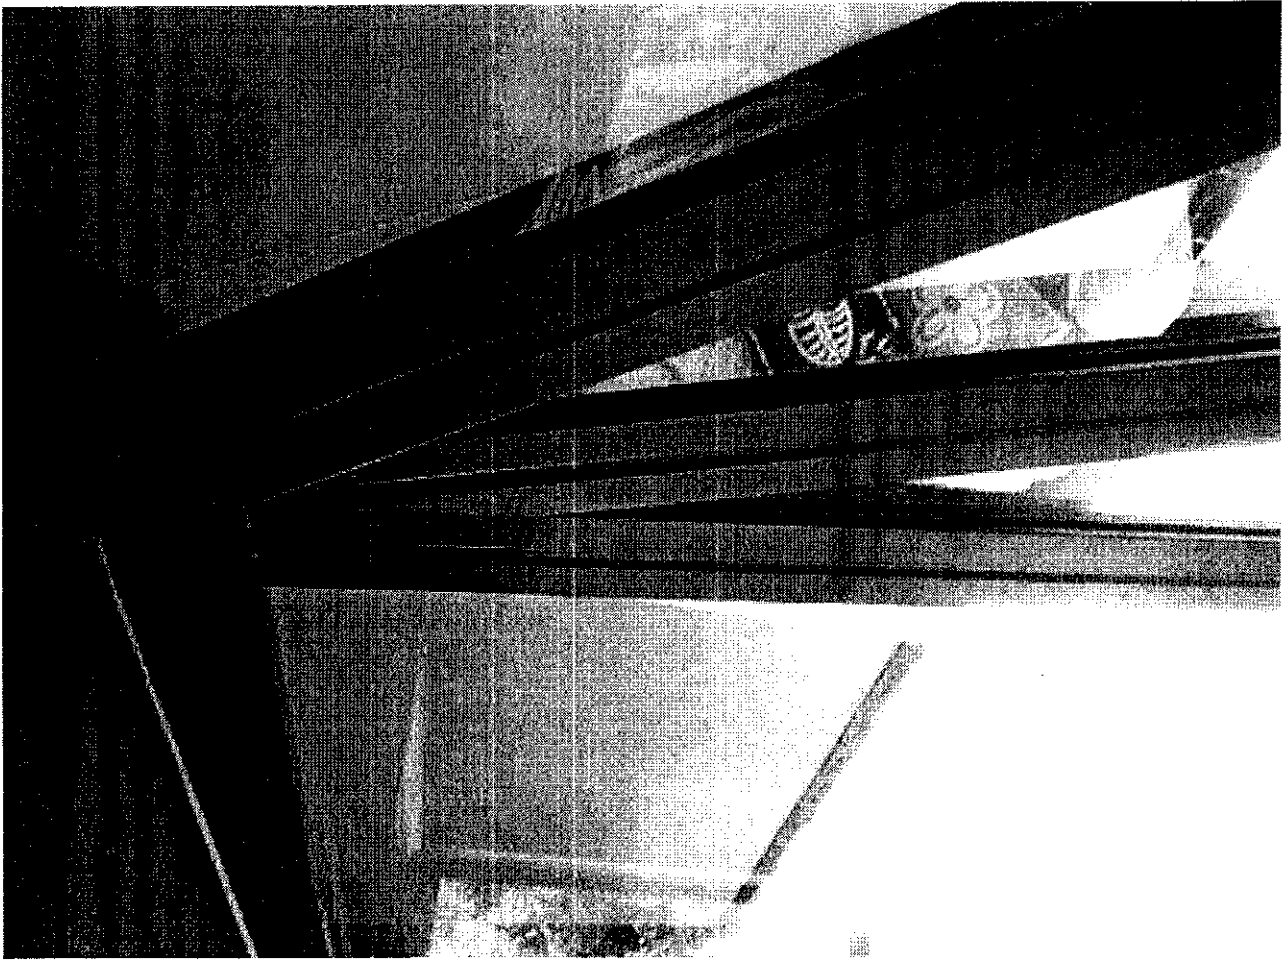
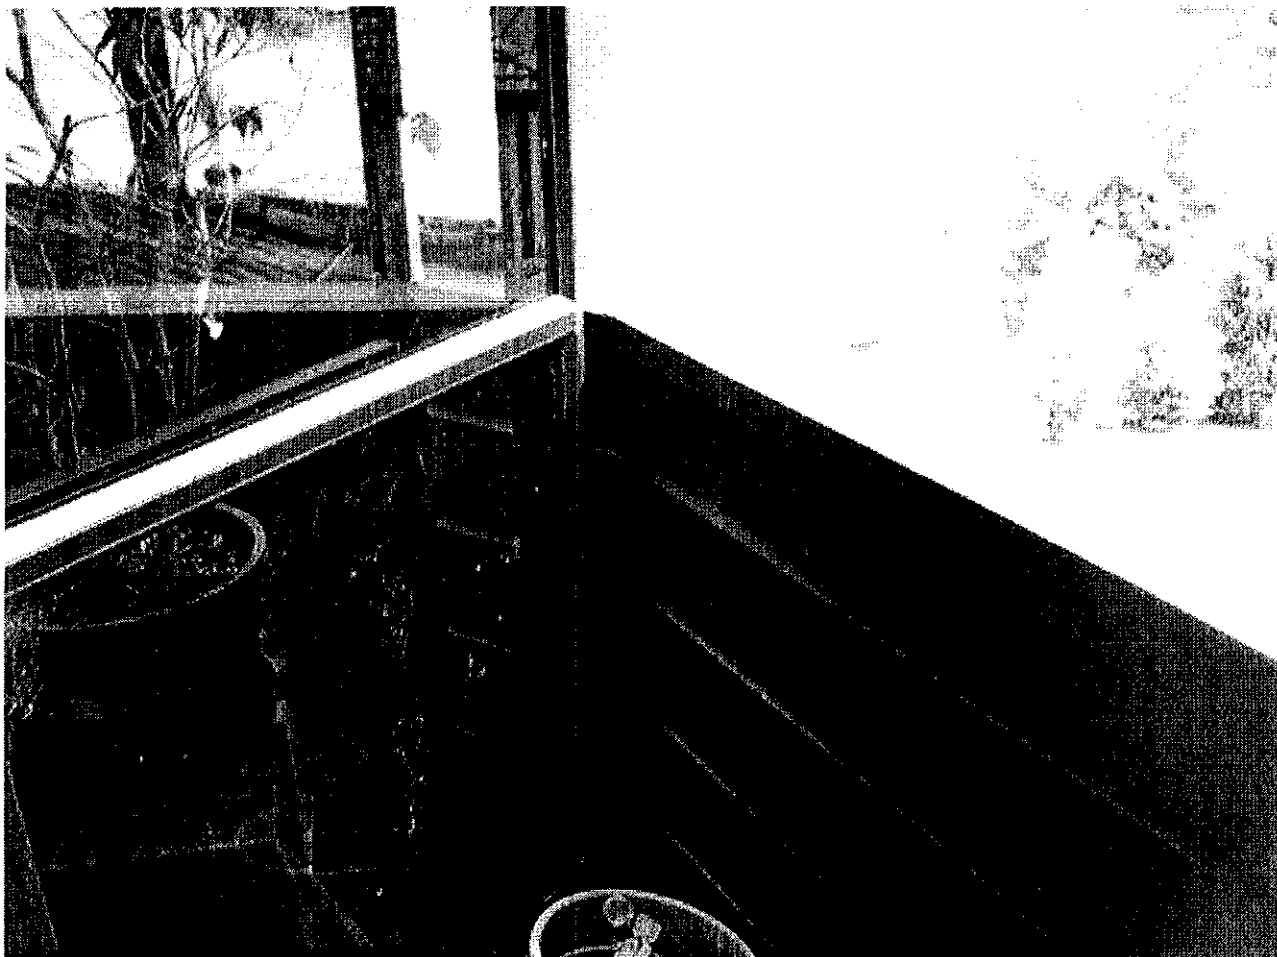
The conservatory shows no major signs of any decay.

The alloy joinery shows no evidence of decay to glazing rubbers due to thermal expansion & contraction or shrinkage.

No chalking of powder coated finishes observed and no atmospheric corrosion observed.

No loss of sealant at joints & corners observed, but please monitor the architectural details.

Current water sealant to the conservatory appears to be in order showing no signs of any deterioration of materials used.

No signs of any water ingress present at time of inspection.

The vertical seal of alloy joinery framework to existing cladding is well sealed and is showing no decay to sealant.

The bottom plate or bottom frame of alloy conservatory is well secured to the top rail of deck.

Drainage to the conservatory consists mostly of metal spouting which shows no evidence of rust decay or corrosion to downpipes.
